PROPERTY INSPECTION REPORT

Concerning: **123 Main Street, Anywhere, Texas 75000**

By: Clark Steven Covey

8/2/2015

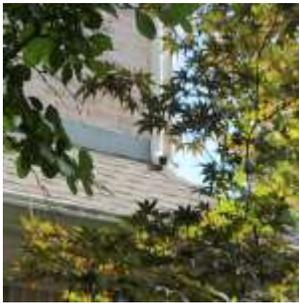
Downspout on upper roof

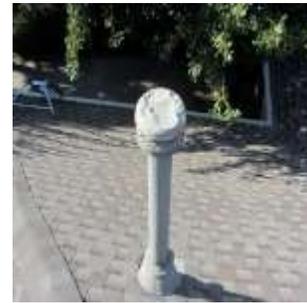
Hail damage

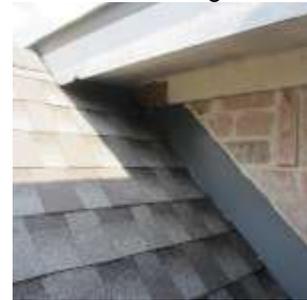
Pest damage to fascia

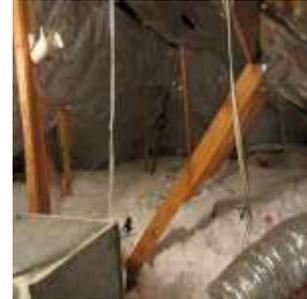
Radiant barrier

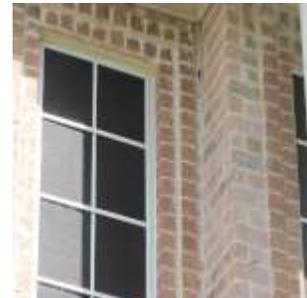
Minor brick separation

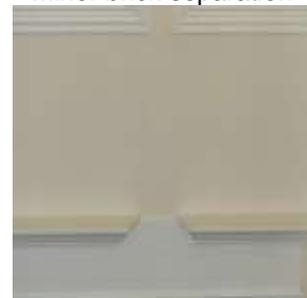
Prior wall damage

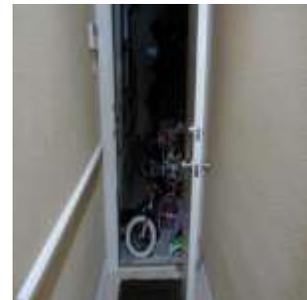
Small garage access door

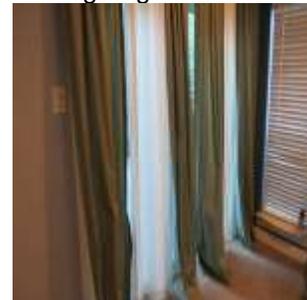
Sliding door

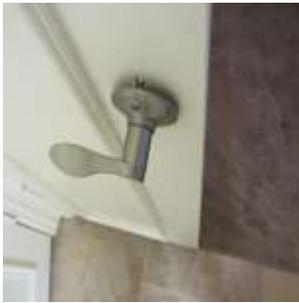
Bathroom door handle

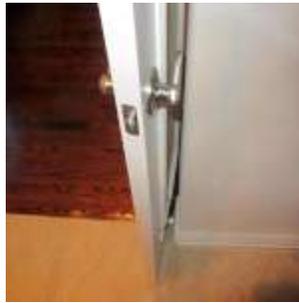
Missing door stop

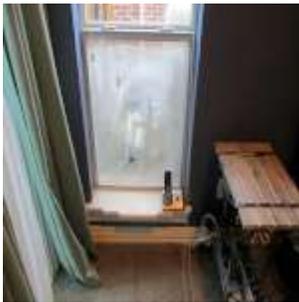
Thermopane window

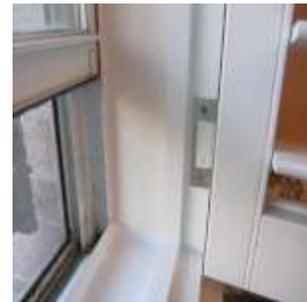
Prior water intrusion

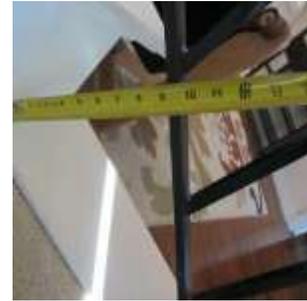
- Unable to inspect room below stairs.
- Height of handrail should be between 34"-38".
- **Triangular opening must not allow a sphere greater than or equal to 6".**
- **Upstairs railing slightly loose to floor.**

Triangular space 9"

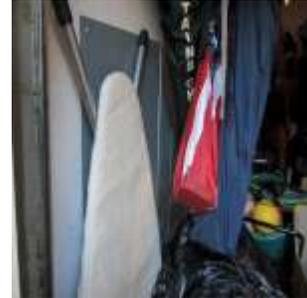
Electrical panels

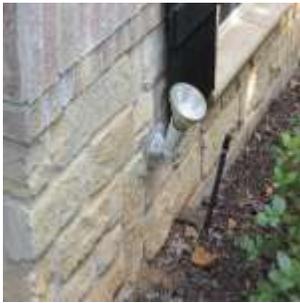
Exterior light water protection

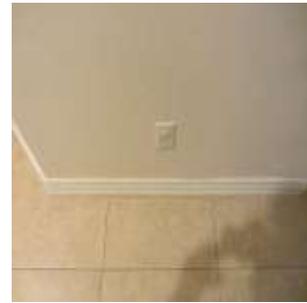
Hallway receptacle

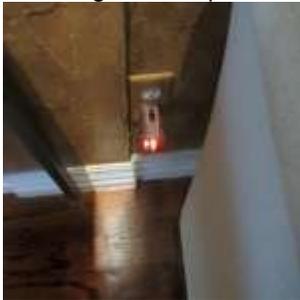
Hot & neutral reversed

- Inspector recommends that an evaluation and any necessary repairs be performed by a qualified electrical contractor

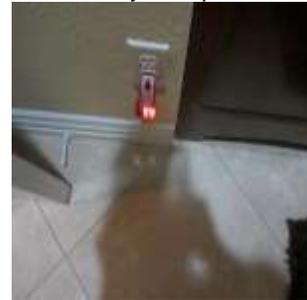
Missing GFCI

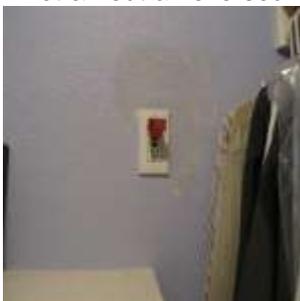
GFCI in Master closet

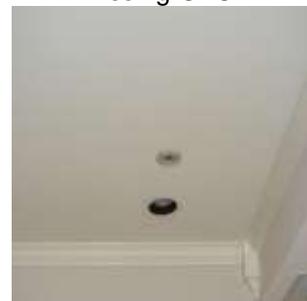
Missing smoke detector

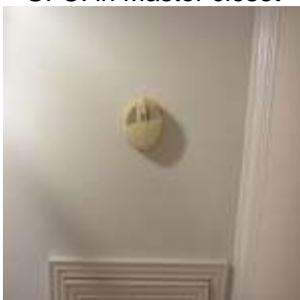
Upstairs smoke detector

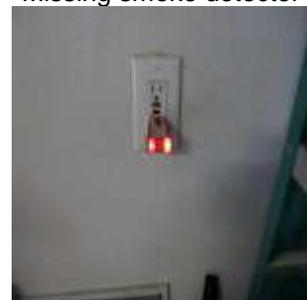
Open ground

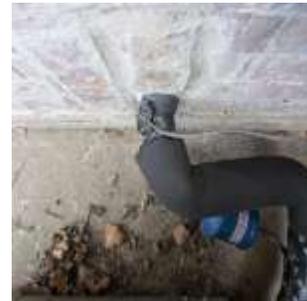
Deteriorate insulation

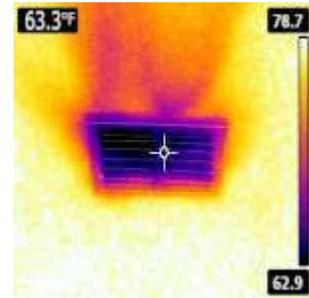
- Output temperature should measure 14°-22° cooler than return air.
- Upstairs return air measured 81.0°F. Output should be 59.0°-67°F and measured 54.3°-63.3°F.
- Return air measured 71.2° & 74.5°F. Output should be 49.2°-60.5°F and measured 50.9°-70.5°F.

Upstairs warmest output

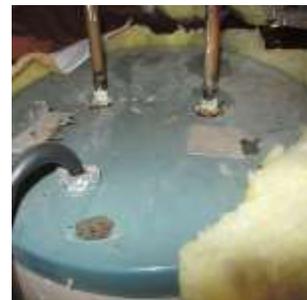
- Three water heaters (one in Northwest attic and two in Southeast attic)
- Minimum of 30" workspace in front of water heater required with a minimum 24" wide solid passage floor to equipment.
- Galvanic corrosion noted to connectors.

Galvanic corrosion

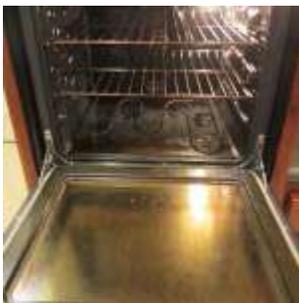
- Appears to be functioning as intended.
- Electric ovens
- Gas range
- Oven variance should be +/- 25°. Both ovens were heated to 350°F and heat slightly higher than accepted norms.
- Upper oven registered at 378°F.
- Lower oven heated and tested approximately 45 minutes later, registered at 381°F.
- Upper oven needs cleaning.

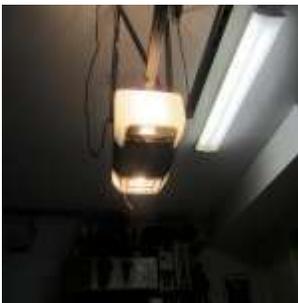
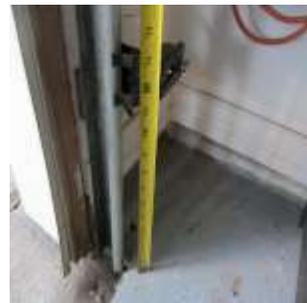
- Appears to be functioning as intended.
- Remotes are not tested.
- **Downforce needs adjusting.**
- **Floor sensors are too high – should not be higher than 6” from floor.**
- Unable to fully inspect single-car garage due to personal belongings.

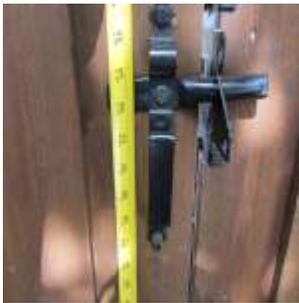
Latch too low

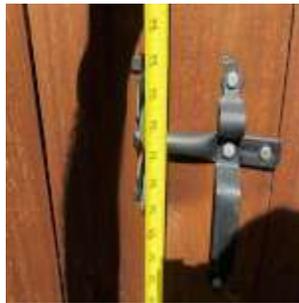
Latch too low

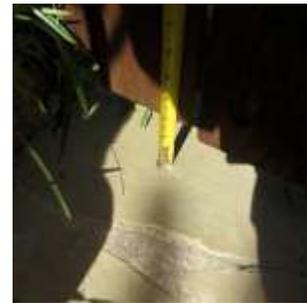
Gate too high

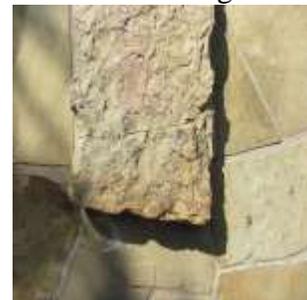
Decorative rock cracked

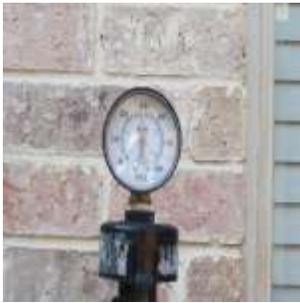
DE filter guage

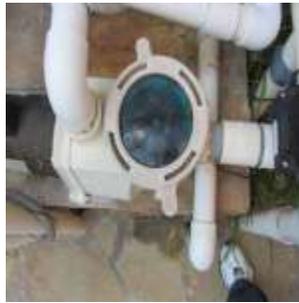
Possible leak

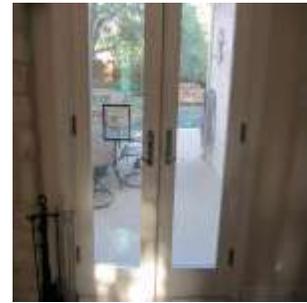
Missing alarms

All doors with direct access to the pool through that wall shall be equipped with an alarm which produces an audible warning when the door and its screen, if present, are opened. The alarm shall sound continuously for a minimum of 30 seconds immediately after the door is opened and be capable of being heard throughout the house during normal house-hold activities. The alarm shall automatically reset under all conditions. The alarm system shall be equipped with a manual means, such as touchpad or switch, to temporarily deactivate the alarm for a single opening. Such deactivation shall last for not more than 15 seconds. The deactivation switch(es) shall be located at least 54 inches (1372 mm) above the threshold of the door.
